Camelot Home Inspections, Inc.
10 Public Square
Willoughby, Ohio 44094

Property Condition Report

1234 Main St.
Mentor, OH 44060

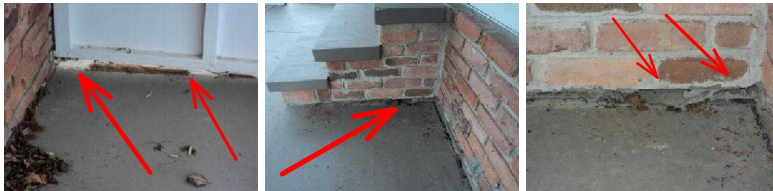
1. Walks: Concrete - Cracked
2. Patio: Concrete - Settlement observed

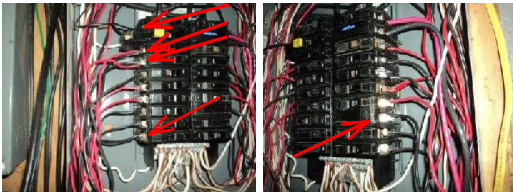
1. Basement Electric Panel Breakers: CU/AL - Double tap wiring on #1,5,7,12,21:fire hazard, Contact a qualified electrician for further evaluation:breaker connections appear to be rated for 2 wires but label rating reads 1

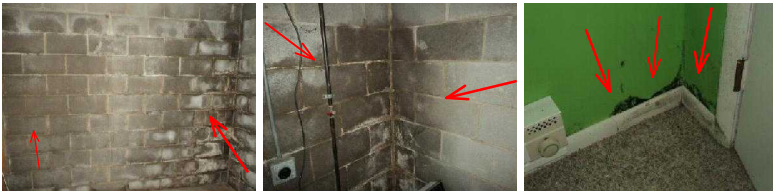
7. Main Basement Moisture Location: Walls - **Water stains present mostly in n.e. corner and front south wall adjacent garage:active, Mold present on floor joists:potential health concern**
